IC Low Pressure

Low Pressure Observed - with and without a leak.

Technology: Ion Chromatography

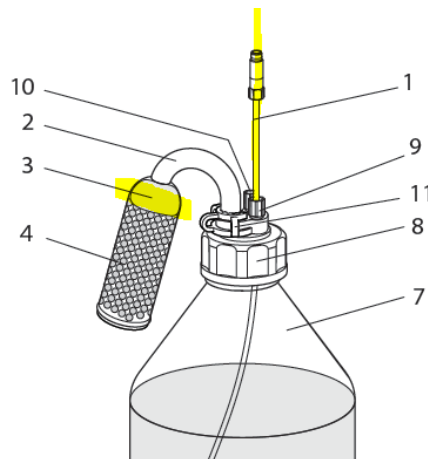
- If air bubbles are observed in the eluent container collected along the glass or on the eluent line (picture below), the eluent should be remade by first degassing the water.

- The ascarite is exhausted and blocks absorber tube #3. The eluent bottle will pressurize when the IC Pump starts. Replace the ascarite. Be sure not to over-pack. Allow some movement in the absorber tube.

- A crimp or pinch in tubing #1 prevents eluent. Follow the tubing to the IC connection and check for microfracture. If crimped, pinched cracked, replace the eluent line.

- Eluent tubing out of the degasser: 6.1834.090 [Connecting tubing for degasser pump, 125 mm | Metrohm](#)
 - Eluent tubing from bottle to degasser, 2m: 6.1834.080 [Aspiration tubing, 2 m | Metrohm](#)

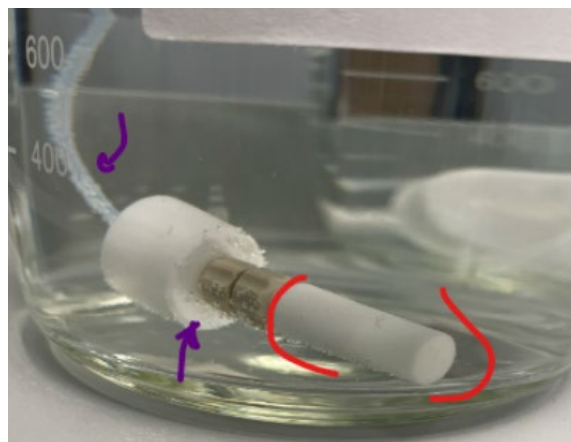
- The eluent filter is dirty and is blocking flow (circled in red) - if this is in use and 18M Ω water is used to make the eluent, please remove it as this causes more issues such as contamination & pressure.

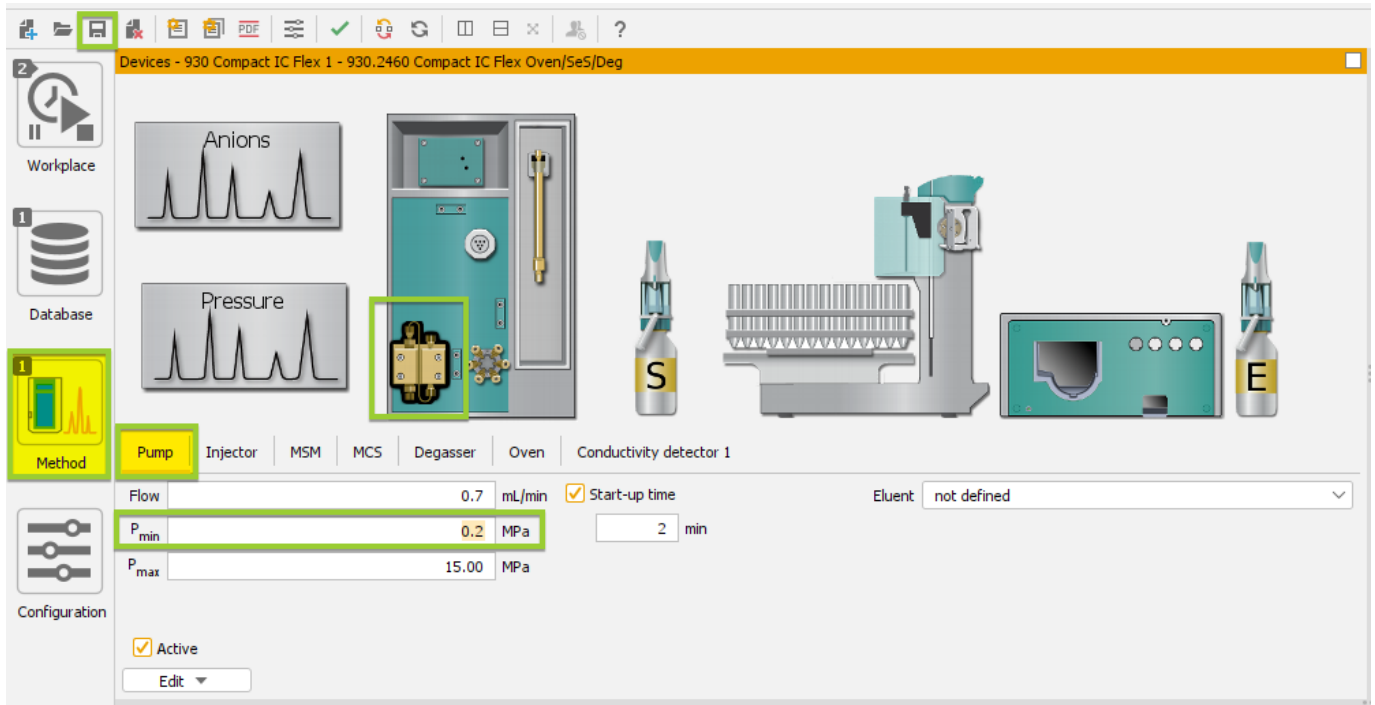
Often, the IC's minimum pressure defaults to 0MPa. When a leak is observed or air bubbles are trapped in the high-pressure flow path, the system rarely reaches 0MPa. The hardware will continue to run and cause unexpected issues, such as inaccurate sample results, eluent running dry, possible damage to the column, MSM rotor, pump seals, etc.

To update the P_{min} in the method (see example screenshot below):

- Go to the Method tab in MagIC Net > File > Open > Select the desired Method.
- Select the Pump on the IC > Update P_{min} to 0.2MPa (29 psi)
- Don't forget to save the method. File > Save.
